Distress Call for Maintenance and Repair of Bridges, a Case Study of Abakpa Bridge along Nike Road Enugu, Nigeria

AMULU, Chijioke Paul

DEPARTMENT OF CIVIL ENGINEERING,

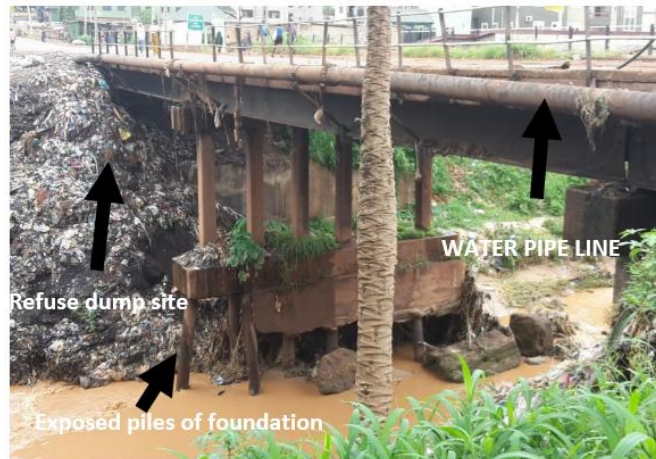
Figure 3.1 The effect of Environmental degradation on the Abakpa Bridge along Nike Road, Enugu

Figure 3.1 displays the present condition of the Abakpa bridge. From the view, the column base cap and the piling foundations have been exposed by the scouring of the riverbed caused by the Ekulu River that flows under the bridge. In other words, the cross-examination carried out on the bridge indicated that the base of the foundation piles had been exposed to external factors like scouring and flooding. Some piles of foundations have been knocked out of position as indicated by the black arrow on the picture. This displacement of the piles out of their normal straight line position could lead to loss of stability and structural integrity of the bridge and subsequently to imminent failure and partial or total collapse of the Bridge, as the case may be. The results obtained from the cross-examination of the bridge, as indicated in Figure 3.1 above, also, showed that under/beside the bridge serves as a dump site for managing domestic and industrial wastes. The decomposition of various waste products dumped at the site may generate leaches and other chemical compositions that will attack the structural steel components of the bridge like the structural steel girder beams, leading to corrosion and rusting. This process will be gradual and progressive, which if unchecked, could trigger the bridge to failure or collapse. In other words, this can trigger corrosion or environmental degradation. Moreover, when this refuse decays, they tend to pollute the water and the environment, thereby, making the acidic content of the water to become high. When it comes in contact with the exposed steel beams, it may result in corrosion. As such, failure of the steel beams may lead to loss of structural integrity, strength, and stability of the bridge. Overloading of the Bridge beyond its initial design load, cannot be ignored. It does happen on this Bridge because no device or agency of the government monitors and checks the values of loads from heavy-duty trucks crossing to and fro on the bridge. This puts a lot of traffic pressure on the Abakpa Bridge which many fears would collapse anytime soon.

Figure 3.1 above, also indicated an extra load on the bridge from the water supply pipeline system whose load was not put into consideration initially during the analysis, design, and construction of the bridge. The loads from flowing water may as well, induce extra stresses on the various components of the bridge which could trigger failure due to fatigue and subsequently collapse.

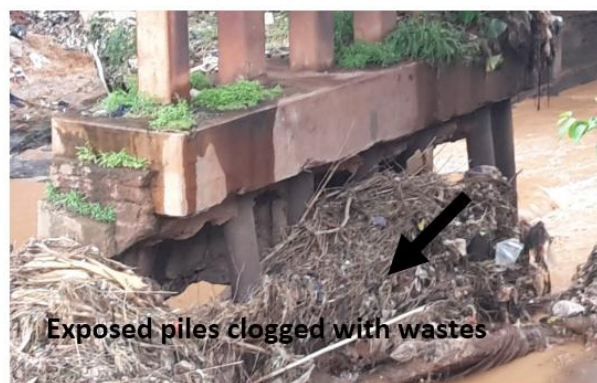
Figure 3.2 The exposed pile foundations of the center columns of the Abakpa bridge

Figure 3.2 above displays a pictorial view of the column base cap and the pile foundation. The base cap is already being suspended, as a result of flooding and scouring of the riverbed caused by the Ekulu River flowing under the bridge. This washes away the concrete components and soils protecting the column base cap and foundation. For this reason, this bridge is likely to collapse in the near future. The exposed piles of the foundation have been clogged by debris carried by the flowing Ekulu river which obstructs the free flow of water. However, there are possibilities of the river carrying heavy wood logs and massive loose concrete components and colliding with the exposed pile base cap and piles of the foundation. This can lead to instability and loss of structural integrity of the bridge. From the cross-examination exercises carried out on this bridge, there is a serious distress call for maintenance and repairs on the bridge to evade imminent failure and collapse.

Other components of the bridge, like the slab deck, the steel girder beams, the bearing, the column, and its caps are in good shape. However, the instability that is gradually setting in on the foundation of the bridge, is putting more stress and fatigue on other components of the bridge. Failure and collapse of this bridge can only be avoided through planned further inspection, detailed maintenance design, and repair programs on the foundation. The dumping of refuse on and beside the bridge should be stopped due to the environmental impact it has on the bridge and the contamination of the Ekulu River. The clogged items should be removed to enable free flow of the Ekulu River.

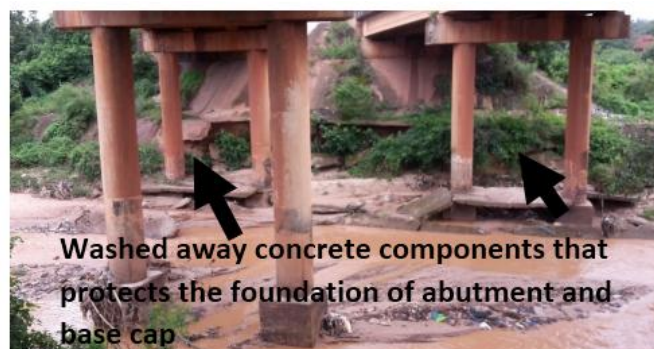
Figure 3.3 The Scouring of River-bed at Abakpa fly-over bridge

Figure 3.3 above shows the falling off of concrete components that protect the abutment and pile caps together with some soils of the bridge's foundation as a result of the scouring of the riverbed. The scouring of the riverbed by the Ekulu River that flows under the other two spans of the bridge is gradually washing away concrete components protecting the foundations of the abutment and piles base caps. This external factor caused by scouring is a progressive activity that may lead to failure and subsequently collapse of the bridge, if this distress calls for maintenance and repair made by this research, is not answered on time. This was exactly one of the main causes of the partial collapse of the new artisan bridge as reviewed in this study.

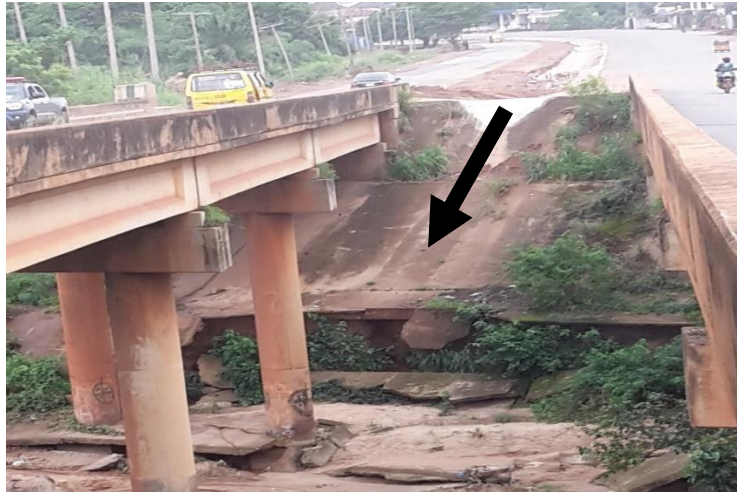
Figure 3.4 The effect of Run-off from rainfall on the concrete components protecting the abutment foundation at the Abakpa fly-over bridge.

Figure 3.4 above indicates the effect of run-off after rainfall, flooding at the center of the two fly-over bridges, directly from the top to the concrete made to protect the abutment. There is no drainage channel constructed to divert or control the run-off water down to the Ekulu River. The flooding also contributes to the gradual washing away of the concrete components and soils protecting the abutment. This external factor will progressively expose the piles' foundation which may subsequently lead to partial or total collapse soon when not corrected on time. In other words, it causes erosion along the abutment base due to the high flowing velocity of the run-off water. Thereby, exposing the abutment base to failure.

On the maintenance and repair history of this fly-over bridge, information collected from the cross-examination on the bridge indicated that there is ongoing maintenance and repair on the asphaltting of the slab deck at the moment (2024). However, no major maintenance has been carried out on other components of the bridge since it was constructed. There is every need to divert the direction of flow of flooding from run-off water, away from the abutment and pile caps foundation of the Bridge.

- There is need for a well-designed drainage channels for the diversion of run-off water flooding directly to the foundations of the bridges. This will help prevent the washing away of the concrete components and soils meant to protect the abutment and pile cap foundations.
