## An Urban Transformation Example: Istanbul Tarlabası

One example of the reports prepared for the immovable cultural asset located in Istanbul province, Beyoğlu district, Tarlabası Boulevard 386 block, 24 parcel is as follows:

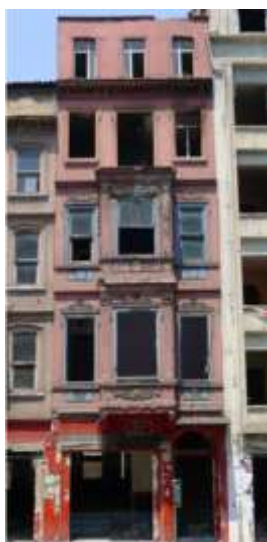
**Figure 1. Facade of the building viewing the Tarlabası Boulevard** **Figure 2. Facade of the building viewing Dernek Avenue**

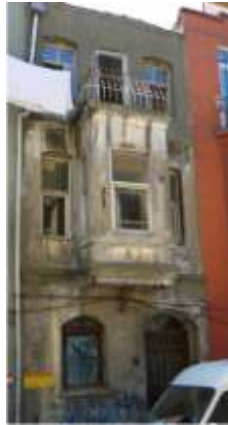
The building located at Eski çeşme Avenue is composed of a ground floor, a basement floor and two normal floors. It is in the form of attached buildings (Figure 3, 4).

**Figure 3. Entrance facade of the building viewing Eski Çeşme Avenue Figure 4. Outlook of the bow window located on the front facade of the building 386 block, 24 parcel**

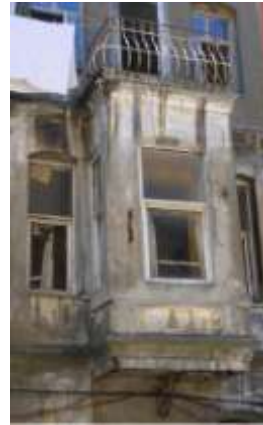
- The construction flooring is wooden. Wood is used for floor covering too.
  - There is a bay window at one floor. The bay window was supported by a steel butters in the original construction. However, this butters was completely rusted as a result of corrosion. Bay window floor is wooden floor on which timber-work coating is applied. The base of bay window is surrounded by steel profile. However, this profile has completely corroded.

- The facade is coated with a thick cement plaster. Some cracks occurred particularly on the bay window part in the plaster. It is seen these cracks occurred as a result of weather conditions and disrepair. Any expression suggesting that the cracks have proceeded towards the internal structure was not found.

Since the buttresses have lost their carrying ability because of material problems, they remain insufficient in carrying the bay windows and so the bay windows are in danger of collapse.

It may be said that performing a structural reinforcement may not give proper results because of the damage that occurred on the bearing system in time due to disrepair. It is considered appropriate to reinstall and evaluate the facade installation of the construction that has lost its originality while replacing the bearing system.

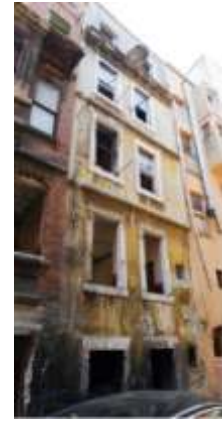
**Figure 6. Facade of the building viewing the Dernek Avenue 385 block, 4 parcel**
