Production Quality Control Using Six Sigma Method in Shock Absorber Industry (Case Study at PT.XYZ)

PT.XYZ as a distributor for manufacturing vehicle shock absorber parts has a problem with the production front fork parts, namely a leak in the area above the front fork found in the claim market. Researchers used the DMAIC method, where there are steps to reduce defects and variations carried out systematically by defining, measuring, analyzing, improving, and controlling which are known as the 5 phases of DMAIC (Define, Measure, Analysis, Improvement, Control). Research and data collection were taken from one of the claim market cases at PT. XYZ and PT Astra Honda Motor for the period January to December 2019. The results showed that after the define and measure process was carried out, 2 main problems were found that caused the front fork to leak in the upper area, namely a defective o-ring condition and minus inner tube dimensions. This is evidenced by the measurement of process capability, where the defective o-ring conditions obtained C_p 0.62 and C_{pk} 0.58 and for the dimensions inner tube minus, the C_p values were 9.4 and C_{pk} 0.24. After that, from the 2 problems, an a

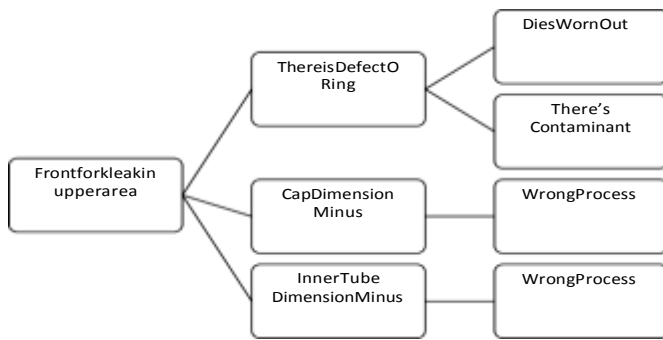
Figure 2: Logic Tree Diagram of Causes for Front Fork Leak in Upper Area

Oil leaks in the front fork can be caused by several things. To see the possible causes of oil leakage, you can see the Logic Tree Diagram in Figure 2 for the process of defining the cause of oil leakage in the upper front fork area, and in Figure 3 are the parts in the upper front fork area.

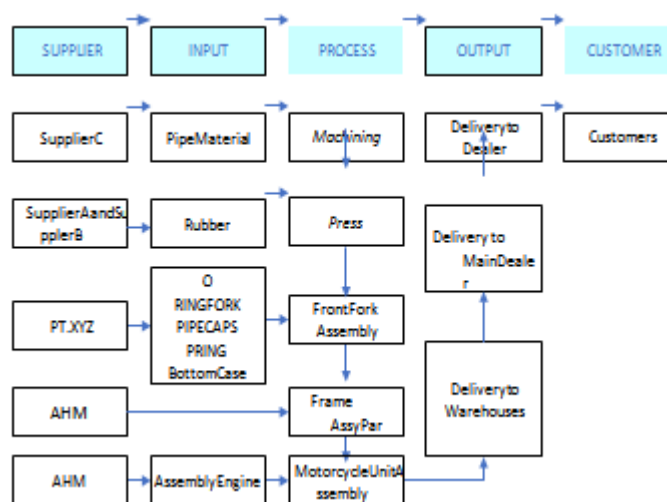
Figure 4: SIPOC Diagram

To define the process of the front fork components and parts associated with the front fork, starting from material suppliers, sub-parts, front fork assembly units, output distribution to consumers, a SIPOC diagram will be made which can be seen in Figure 4 below.

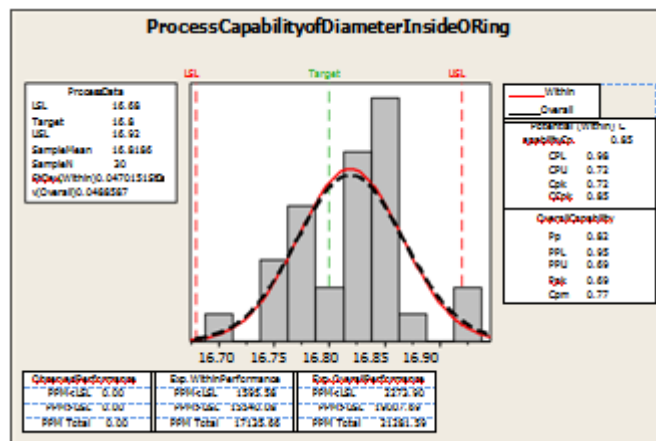
Figure 6: Graphic Data Cp, Cpk Diameter Inside ORing Supplier A

Based on the above calculations, the Cp value is 0.85 and it is concluded that the results of the Process are Enough and it is decided OK.

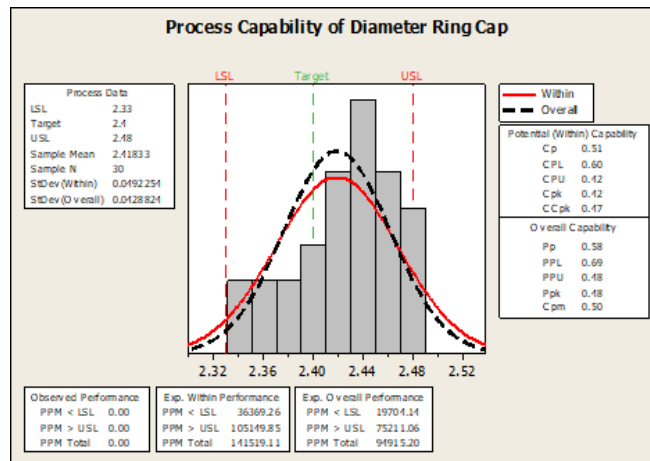
Figure 7: Graphic Data Cp, Cpk Ring Diameter O-Ring Supplier A

Based on the above calculations, the Cp value is 0.62 and Cpk 0.58. From these results, it can be decided that the process is not good and it is decided by NG. Furthermore, the calculation of Cp, Cpk starts on the diameter of the ring cap for supplier B which can be seen in Figure 8 below.

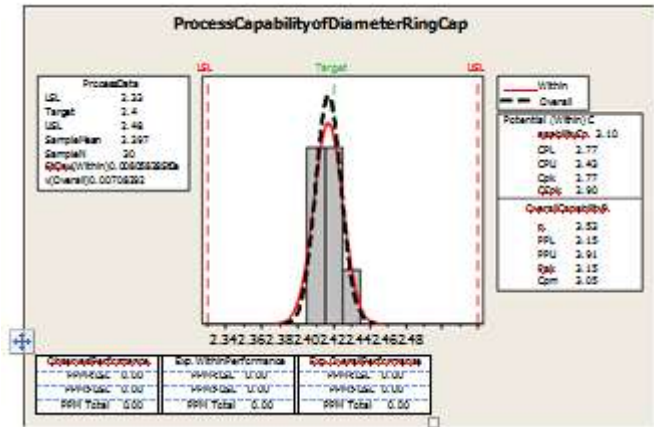
Figure 9: Graphic Data Cp, Cpk Diameter Inside ORing Supplier B

Based on calculations on supplier B, the Cp value is 5.34 and the Cpk value is 5.28, with the Cp/Cpk value obtained, it can be concluded that the results of the process are very good and it is decided that the results of the process are OK

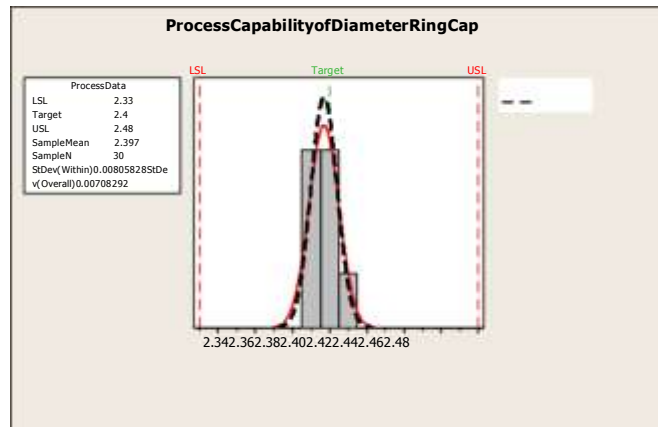
Figure 12: Graphic Data Cp, Cpk Inside Upper Diameter

Observed Performance	Exp. Within Performance	Exp. Overall Performance
PPM < LSL 0.00	PPM < LSL 0.00	PPM < LSL 0.00
PPM > USL 333333.33	PPM > USL 237509.67	PPM > USL 351334.32
PPM Total 333333.33	PPM Total 237509.67	PPM Total 351334.32

Based on the calculation of Cp, Cpk, the value of Cp is 9.4 and Cpk is 0.24. Because the Cpk value is below 0.67, it can be stated that the result of the process is not good and it is decided by NG

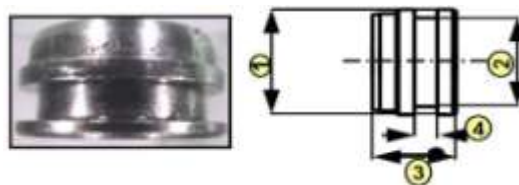
Figure 13: Cap Front Fork Illustration

Based on the above measurement data, especially in the diameter grooving area where the oring is installed, dimensionally there are no dimensional problems so that the conclusion on the front fork cap part is declared OK and no further analysis is needed.

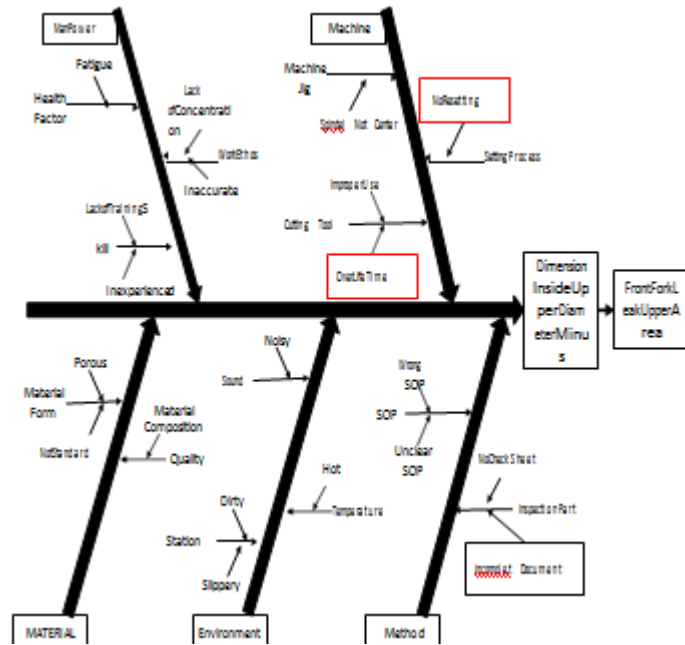
Figure 15: Fishbone Diagram Diameter Inner Tube Minus

The analysis is also carried out the same as the previous part using the fishbone diagram. In the Fishbone Diagram for the minus inner tube problem, the same as the previous diagram the dominant factors that cause problems based on 5M + 1E will be analyzed based on the machining process. The cause and effect diagram of the minus inner tube can be seen in Figure 15 below.

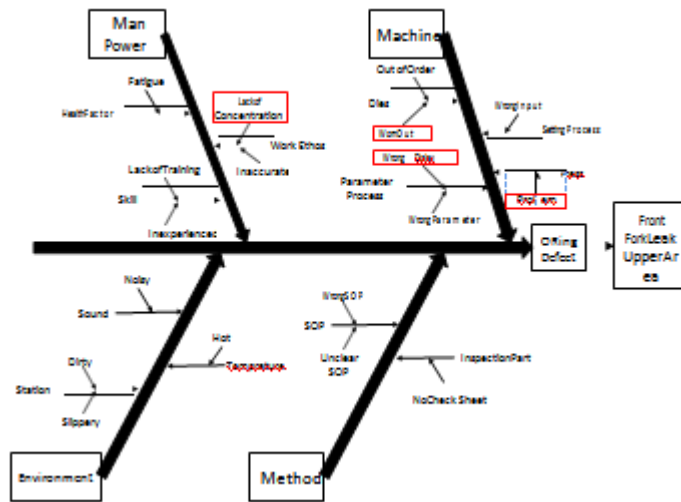
Figure 14: Fishbone Diagram ORing Defect

on 5M+1E, in this diagram, the 5M+1E factor to be analyzed is the pressing process where the process greatly affects the quality of the ring which can be seen in Figure 14 below

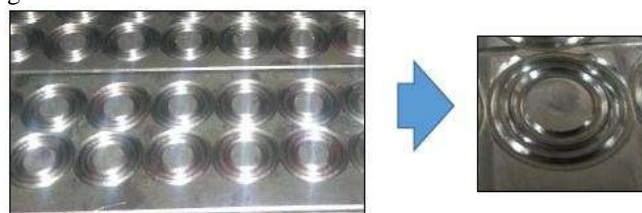
Figure16: Dies at Press Process

In the press process of making an O ring, there are important things that have been previously discussed at the analysis stage that the use of dies is very important in manufacturing. After analysis, the cause of the CP / CPK NG on the ring diameter was caused by the use of the dies itself. When checking the dies, a worn condition is found which can be seen in Figure 16

With the condition of the dies that are worn out, when the pressing process takes place the result of the \rightarrow ring is defective. This defect in the ring causes oil to come out. The

With the discovery of worn-out dies conditions that were not detected by the operator, it is necessary to improve the control of the use of dies to avoid the occurrence of worn-out dies.

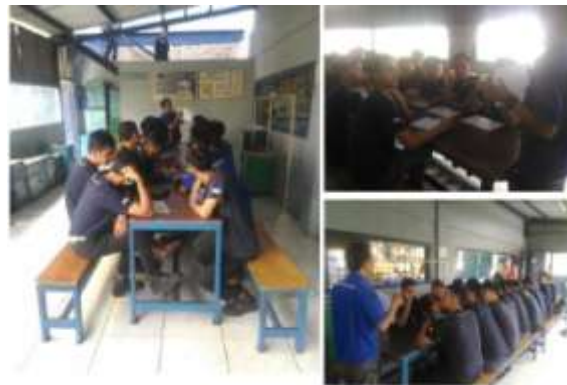
Figure19: SOP Press Process Socialization

Apart from that, the conditions that need to be maintained by the operator are related to the cleanliness of the dies, the condition of the dies where the remaining burr from the previous process can also cause the condition of the o ring to have defects. So that re-socialization is needed for operators so that no important processes in the SOP are missed. Re-socialization has been carried out and can be seen in Figure 19

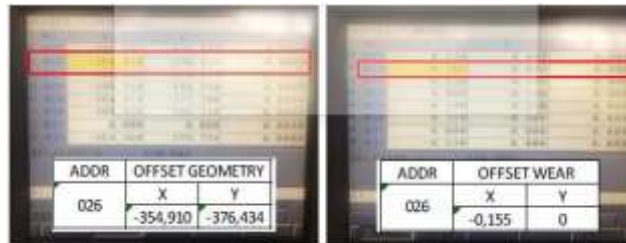
Figure 20: Monitor Setting Parameter Before and After Change Insert

dimension itself is found in the barin (insidediameter) process, which has a gradual in feed. After the analysis was carried out, there was a finding that when the tools were replaced, the operator did not set the offset wear, which caused an insert over to be carried out at the beginning of the feeding process. This is found when the operator has replaced the worn insert with a new insert, the operator does not set the offset wear and is shown on the monitor parameter setting in Figure 20 below

From the above findings, when a new insert is not set the offset wear is set, it will cause when the initial in feed process is carried out the result of the part dimensions will be minus. For the standard diameter itself between 21.6-21.7, if the operator compares the results of the insert insertion before it is replaced and after the insert is replaced. Finding these conditions can cause the inner tube diameter to be minus and cause a leak in the front fork. In the IK

(Work Instructions) document, the replacement of the insert tool is not written in detail, so it needs to be revised for the point of fadding the insert tool settings when the replacement is made

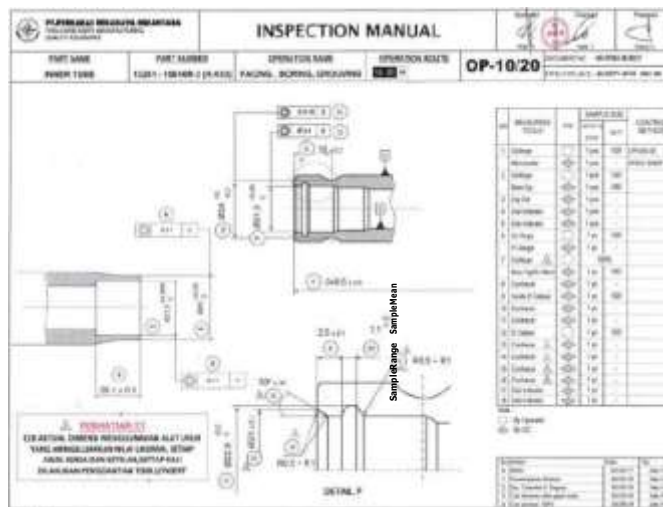
Figure 21: Inspection Manual Revision Inner Tube Part

After repairs have been made which causes the inner tube diameter to be minus, it is followed by inspection of the parts so that if the same problem occurs, the operator can catch the NG part. To better control the production results maximally, improvements were made by adding 100% plug gauge checks and when there was a change of inserts, the dimensions were checked which can be seen in Figure 21 below

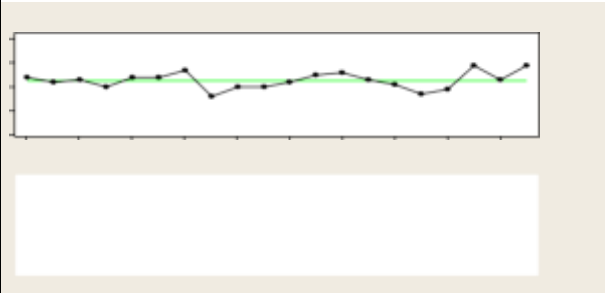
Table 7: X-R Control Chart Ring Diameter O Ring

Xbar-R Chart
 2.450 UCL=2.4509
 2.425
 X=2.4068
 2.400

2.375
 LCL=2.3626
 2.350
 1 3 5 7 9 11 13
 15 17 19

Sample
 0.15
 UCL=0.1381
 0.10
 R=0.0605
 0.05

From the results of the X-R Chart, it can be seen that the data retrieval was carried out 4 times a day for 1 month, showing very good results. This control can be a reference that the improvements made can run well.

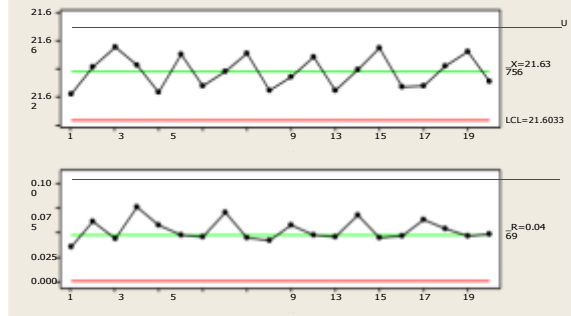
Table 8: X-R Control Chart Dimension Inside Upper Diameter

Section	PartComp.	PartsName	Specific of Quality	Tooling	Sampling
MACHINING		FORKPIPE INSIDE UPPER DIAMETER		CALIPER	4PCS
