Strength and Ductility Test of GFRP Strengthened Corrosion Damaged RC Columns

ABSTRACT: This paper presents the results of an experimental investigation to examine the effectiveness of Glass Fibre Reinforced Polymer (GFRP) wraps on corrosion damaged high strength concrete columns. A total of fourteen specimens of 150mm diameter and height of 600 mm were cast and tested. Each of the seven specimens were subjected to 0%, 15% and 30% level of corrosion-damage and in that one column specimen were used as corroded control. Glass fibre reinforced polymer wraps were used with different configurations such as CSM, UDC and WR. The wrapping was done with 3 mm and 5 mm thickness for each material. All the columns were tested under monotonic loading up to failure, in a loading frame of capacity 2000 kN. Necessary measurements were taken for each load increment. The findings concluded that GFRP wrapped corrosion-damaged concrete columns showed considerable enhancement in the load carrying capacity, deflection and ductility than the control concrete columns.

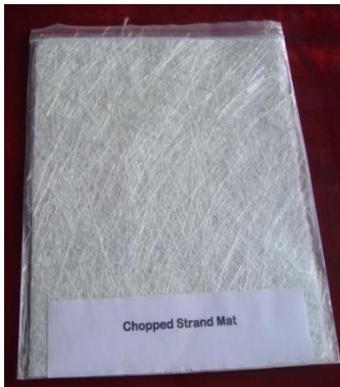
Figure. 1 Chopped Strand Mat Fabric

Glass fibres used for the study have various fibre configurations.

1. Chopped Strand Mat (CSM)
2. Uni-directional Cloth (UDC)
3. Woven Rovings (WR)

The glass fibres used for the study are shown in Figures 1 to 3.

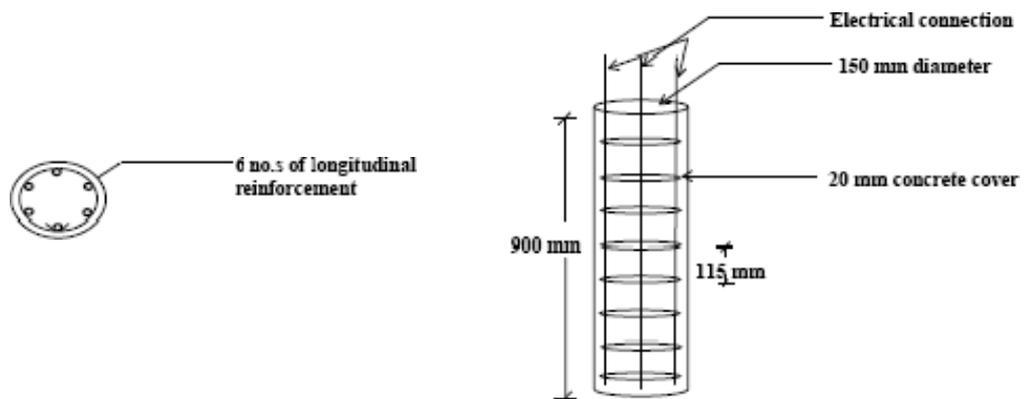
Figure 4: Column Details

All the specimens were 150 mm in diameter and 900 mm in height. The specimens were provided with six bars of 8 mm diameter as longitudinal reinforcement. Each specimen also contained 6 mm diameter ties at a spacing of 115 mm c/c. The longitudinal bars were kept protruded from the column face to accommodate the electrical connections for accelerated corrosion. The details of specimens are shown Figure. 4.

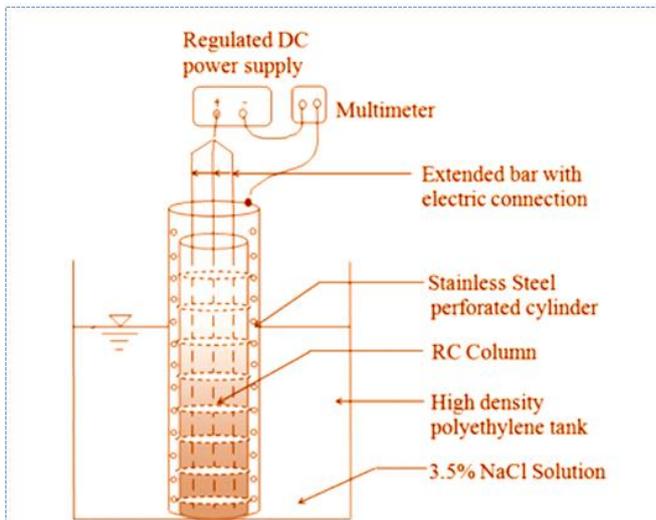
Figure.5: Schematic View of Accelerated Corrosion Set-up

A schematic representation of the corrosion testing is shown in Figure.5. The columns were subjected to accelerated corrosion. The columns were kept immersed in 3.5% NaCl solution in a high-density polyethylene tank. The columns were immersed for a day to ensure full saturation condition. The direction of the current was arranged so that the reinforcement cage served as the anode while stainless steel perforated cylinders, acted as counter electrode. The accelerated corrosion process was achieved by applying a power supply with an output of 32 V and 11 amps. High voltage was used to accelerate the corrosion and shorten the test period. Two levels of corrosion damage, 15% and 30% were induced. The time for corrosion can be estimated by the Faraday's equation,

$$\Delta W = \frac{A_m \cdot I \cdot t}{Z \cdot F}$$

where Δw = mass loss due to corrosion, A_m = atomic mass of iron (55.85 g), I = corrosion current in amps, t = time since corrosion initiation (sec), Z = valency (assuming that most of rust product is due to Fe (OH) 2, Z is taken as 2), F = Faraday's constant [96487coulombs (g/equivalent)]. The corrosion activity was monitored for the columns by measuring the corrosion potential in accordance with the ASTM procedure.

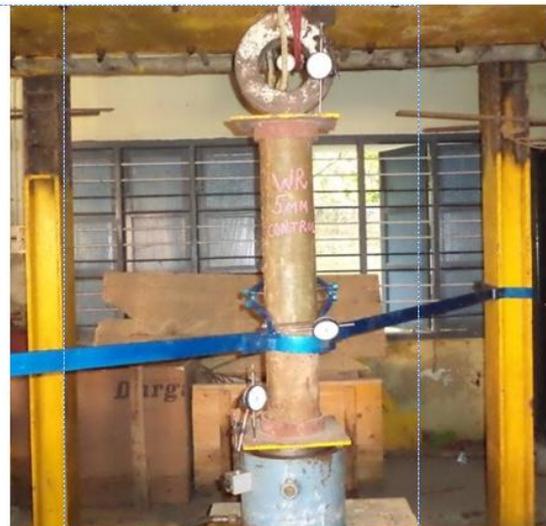
Figure 6: Test Set-up

All the specimens were tested in a loading frame of capacity 2000 kN. To measure the axial compression of the column specimen, two deflectometers with a least count of 0.01mm were fitted at top and bottom of the specimen. A lateral extensometer was provided at mid-height of the column to measure the lateral strain. Figure 6 shows the experimental test set up and instrumentation provided for the test specimens.

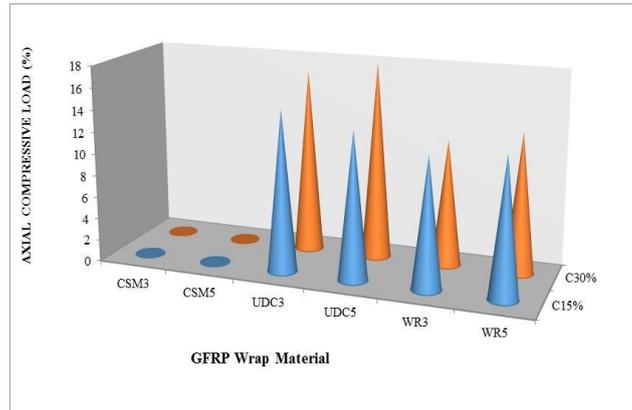
Figure 7. Effect of GFRP Wrap Material on Load Carrying Capacity of Corrosion-Damaged Columns
Effect of GFRP Wrapping on Ultimate Axial Deformation

The effect of GFRP wrap material corresponding to their thickness was calculated by considering CSMGFRP wrapped columns as reference specimen and is presented in Figure.7.

The UDCGFRP wrapped corrosion-damaged columns resulted in higher ultimate load carrying when compared with CSMGFRP of same thickness. The UDCGFRP wrapped corrosion-damaged columns showed an increase in ultimate axial strength in the range of 15.54% to 19.62%. For columns subjected to 30% level of corrosion damage, UDCGFRP wrapped column showed an increase in load carrying capacity in the range of 15.54% and 19.62%.

The columns wrapped with WRGFRP showed a minimal increase in the range of 2.22% to 4.30% in compressive strength when compared to CSMGFRP wrapped columns. For columns subjected to 30% level of corrosion damage, WRGFRP of 3mm and 5mm thickness showed a marginal improvement in ultimate strength by 2.91% and 4.32% respectively. From the results, it is obvious that UDCGFRP provided the most effective confinement to corrosion-damaged concrete columns.

The columns wrapped with 3mm thick CSMGFRP, UDCGFRP and WRGFRP showed an increase in load carrying capacity by 14.5%, 32.2% and 17.8% respectively and those with 5 mm thick CSMGFRP, UDCGFRP and WRGFRP wrap column exhibited an increase of 16.2%, 38.9% and 21.1% respectively for 30% level of corrosion damage.

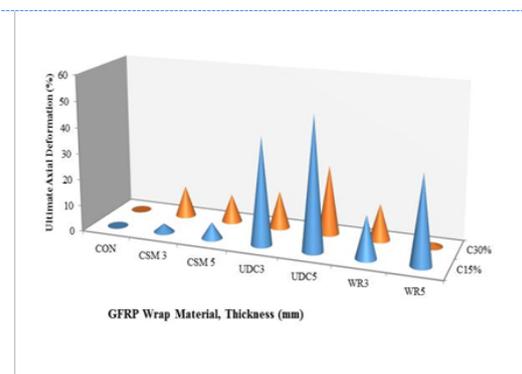
Figure 8. Effect of Various Levels of Corrosion-Damage on Axial Deformation of GFRP Wrapped Columns

The effect of axial deformation on various levels of corrosion-damage is shown in Figure.8. The ultimate axial deformation was decreased due to the corrosion damage induced in the columns. The ultimate axial deformation of column CD 15 CON and CD 30 CON were reduced by 1.59 % and 2.54 % respectively when compared to the non- corroded unwrapped control column NC CON. The specimens with CSMGFRP, UDCGFRP and WRGFRP wrapping showed a decrease in axial deformation by 4.14% to 10.19%, 12.10% to 22.92% and 20.38% to 35.98% in comparison with control column.

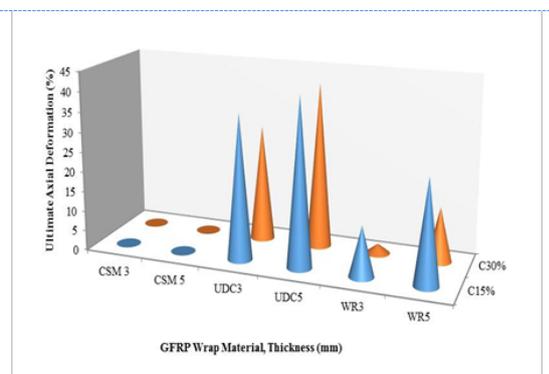
Figure 9. Effect of GFRP Wrap Material on Axial Deformation of Corrosion-Damaged Columns

The effect of GFRP wrap material on ultimate axial deformation is shown in Figure.9. The columns wrapped with WRGFRP showed a nominal decrease in the range of 10.80% to 11.92% in axial deformation in comparison with CSMGFRP wrapped columns. For columns with 15% level of corrosion damage, WRGFRP showed a decrease in ultimate axial deformation in the range of 16.94% to 23.34% in comparison with CSMGFRP wrapped columns. For columns subjected to 30% level of corrosion damage, WRGFRP showed a decrease in axial deformation in the range of 23.44% and 28.72% in comparison with CSMGFRP wrapped columns.

The UDCGFRP wrapped corrosion-damaged columns showed an decrease in ultimate axial deformation by 5.96% to 6.08%. The UDCGFRP wrapped column exhibit an decrease in axial deformation by 8.30% to 8.71 for 15% level of corrosion damage. For columns subjected to 30% level of corrosion-damage, the GFRP wrapping decrease the ultimate axial deformation in the range of 8.62% to 14.18%.

A noteworthy behaviour was found in UDCGFRP material over other materials. This was because fibres in UDCGFRP where so oriented as to effectively confine the concrete. An appreciable decrease in ultimate axial deformation of corroded and wrapped column was observed.

For 15% level of corrosion-damage, the columns wrapped with CSMGFRP, UDCGFRP and WRGFRP showed an decrease in ultimate axial deformation in the range of 0.33% to 3.04%, 2.81% to 5.75% and 6.01% to 16.66% respectively. For column specimens subjected to 30% level of corrosion-damage, FRP wrapping decreased the ultimate axial deformation in the range of 3.97% to 4.73% for CSMGFRP, 6.70% to 12.95% for UDCGFRP and 16.54% to 23.88% for WRGFRP.

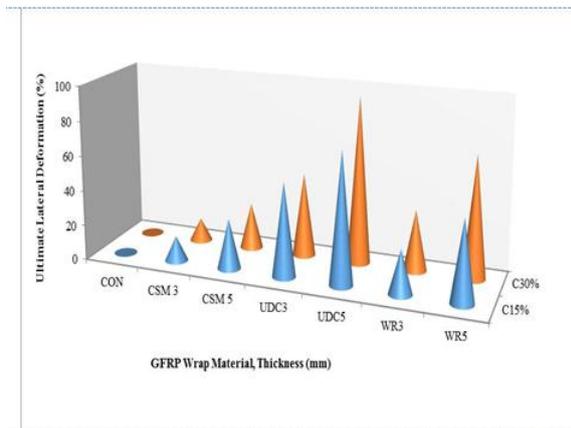
Figure 10. Effect of Various Levels of Corrosion-Damage on Lateral Deformation of GFRP Wrapped Columns

The effect of GFRP wrapping on ultimate lateral deformation for various levels of corrosion damage is shown

in Figure. 10. The ultimate lateral deformation in corroded column was decreased by 9.68% and 21.94% for 15% and 30% level of corrosion damage.

For 15% level of corrosion-damage, the columns wrapped with CSMGFRP, UDCGFRP and WRGFRP exhibit an decrease in lateral deformation by a maximum of 10.97%, 54.84% and 26.45% respectively when compared with the control column.

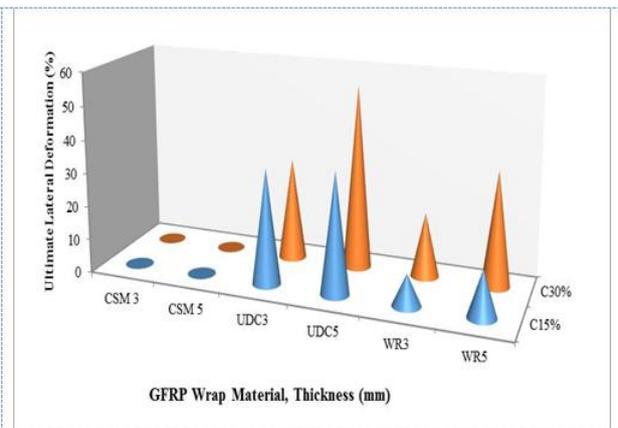
Figure 11. Effect of GFRP Wrap Material on Lateral Deformation of Corrosion-Damaged Columns

The influence of GFRP wrap material on ultimate lateral deformation is presented in Figure.11.

The columns wrapped with WRGFRP showed a decreased in the range of 6.92% to 13.96% in lateral deformation when compared to CSMGFRP wrapped columns. For columns subjected to 15% level of corrosion damage, WRGFRP showed a decreased in ultimate lateral deformation by 13.95%. For columns subjected to 30% level of corrosion damage, WRGFRP showed decrease in lateral deformation in the range of 6.92% to 9.64%. For columns subjected to 15% and 30% level of corrosion damage, UDCGFRP wrapping decreased the ultimate lateral deformation by 39.53% and 39.15%.

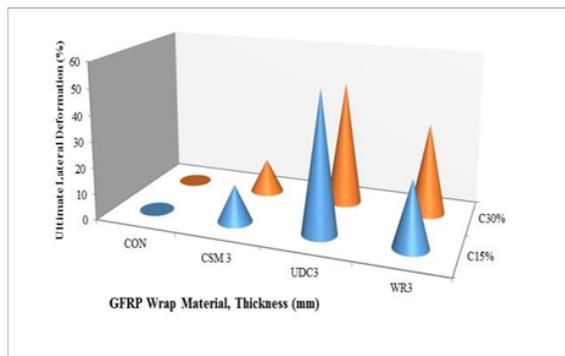
Figure 12. Effect of 3 mm Thick GFRP Wrap on Lateral Deformation of Corrosion-Damaged Columns

The influence of GFRP wrap thickness on lateral deformation is presented in Figures. 12 and 13.

For test specimens subjected to 15% corrosion damage level, 3 mm thick CSMGFRP, UDCGFRP and WRGFRP showed a decrease in lateral deformation by 14.29%, 52.86% and 30%. For specimens subjected to 15% level of corrosion damage, 5 mm thick CSMGFRP, UDCGFRP and WRGFRP showed a decrease in lateral deformation by 22.85%, 71.43% and 40%.

For 30% level of corrosion damage, the columns with 3mm thick GFRP wrapping showed a decrease in ultimate lateral deformation by 32% for CSMGFRP, 66.94% for UDCGFRP and 40.5% for WRGFRP and those with 5mm thick GFRP wrapping exhibit a decrease in lateral deformation by 37.10% for CSMGFRP, 90.90% for UDCGFRP and 50.41% for WRGFRP.

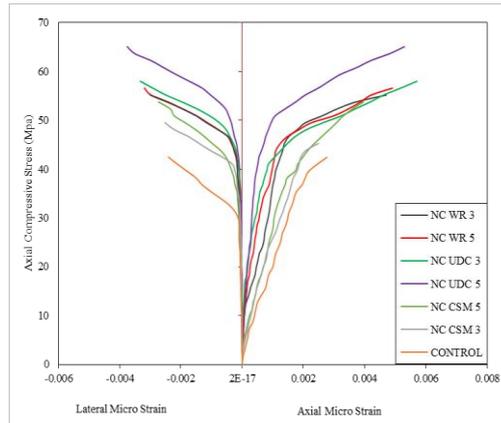
Figure 14. Stress-Strain Response for 0% Level of Corrosion-Damaged Columns

The stress-strain curves for columns with 0% and 30% level of corrosion damage is shown in Figures. 14 to 16.

The corroded wrapped columns experienced a large strain value. The corroded control column failed at reduced stress with increase in level of corrosion damage. On increasing the thickness of GFRP wrapping, the stress level moved up to a certain extent. The UDCGFRP wrapping performed well in both corroded and non-corroded columns.
