## An Urban Transformation Example: Istanbul Tarlabası

One example of the reports prepared for the immovable cultural asset located in Istanbul province, Beyoğlu district, Tarlabası Boulevard 386 block, 24 parcel is as follows:

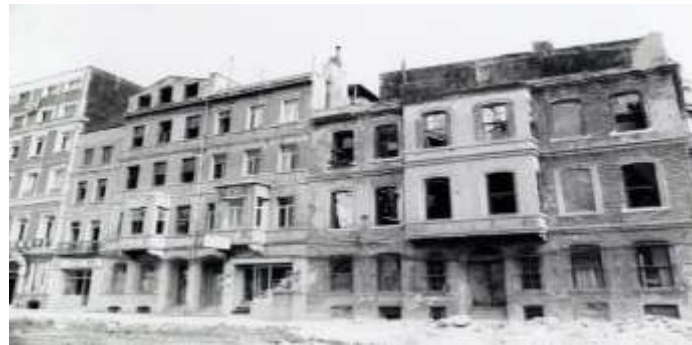
- The facade is coated with a thick cement plaster. Some cracks occurred particularly on the bay window part in the plaster. It is seen these cracks occurred as a result of weather conditions and disrepair. Any expression suggesting that the cracks have proceeded towards the internal structure was not found.

There are plaster and paint shedding and cracks on exterior wall surfaces of the building.

**Figure 6. Facade of the building viewing the Dernek Avenue 385 block, 4 parcel**

It may be said that performing a structural reinforcement may not give proper results because of the damage that occurred on the bearing system in time due to disrepair. It is considered appropriate to reinstall and evaluate the facade installation of the construction that has lost its originality while replacing the bearing system.
