Distress Call for Maintenance and Repair of Bridges, a Case Study of Abakpa Bridge along Nike Road Enugu, Nigeria

AMULU, Chijioke Paul

DEPARTMENT OF CIVIL ENGINEERING,

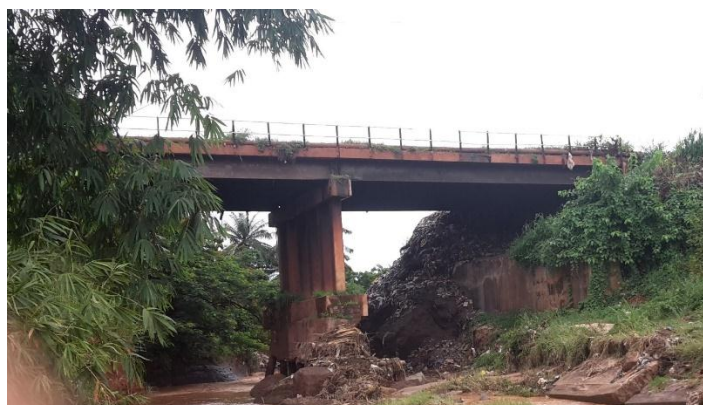
Figure 3.1: The Abakpa Bridge along Nike Road, Enugu

Figure 3.1 displays the present condition of the Abakpa bridge. From the view, the column base cap and the piling foundations have been exposed by the scouring of the riverbed caused by the Ekulu River that flows under the bridge. In other words, the cross-examination carried out on the bridge indicated that the base of the foundation piles had been exposed to external factors like scouring and flooding. Some piles of foundations have been knocked out of position as indicated by the black arrow on the picture. This displacement of the piles out of their normal straight line position could lead to loss of stability and structural integrity of the bridge and subsequently to imminent failure and partial or total collapse of the Bridge, as the case may be. The results obtained from the cross-examination of the bridge, as indicated in Figure 3.1 above, also, showed that under/beside the bridge serves as a dump site for managing domestic and industrial wastes. The decomposition of various waste products dumped at the site may generate leaches and other chemical compositions that will attack the structural steel components of the bridge like the structural steel girder beams, leading to corrosion and rusting. This process will be gradual and progressive, which if unchecked, could trigger the bridge to failure or collapse. In other words, this can trigger corrosion or environmental degradation. Moreover, when this refuse decays, they tend to pollute the water and the environment, thereby, making the acidic content of the water to become high. When it comes in contact with the exposed steel beams, it may result in corrosion. As such, failure of the steel beams may lead to loss of structural integrity, strength, and stability of the bridge. Overloading of the Bridge beyond its initial design load, cannot be ignored. It does happen on this Bridge because no device or agency of the government monitors and checks the values of loads from heavy-duty trucks crossing to and fro on the bridge. This puts a lot of traffic pressure on the Abakpa Bridge which many fears would collapse anytime soon.

Figure 3.1 above, also indicated an extra load on the bridge from the water supply pipeline system whose load was not put into consideration initially during the analysis, design, and construction of the bridge. The loads from flowing water may as well, induce extra stresses on the various components of the bridge which could trigger failure due to fatigue and subsequently collapse.

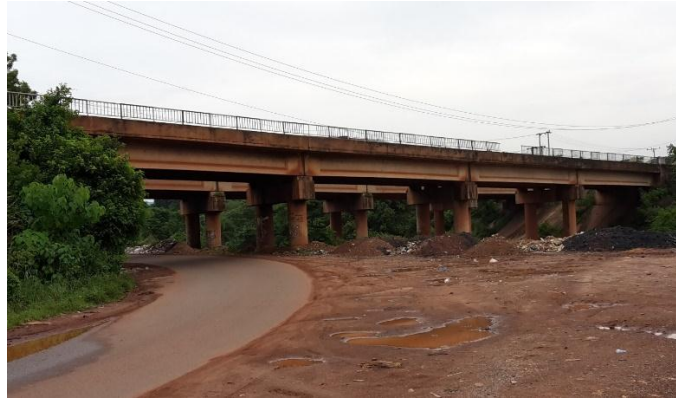
Figure 3.2: The Abakpa fly-over bridge, at 82- Division axis along the Enugu-Onitsha Express

Figure 3.2 above displays a pictorial view of the column base cap and the pile foundation. The base cap is already being suspended, as a result of flooding and scouring of the riverbed caused by the Ekulu River flowing under the bridge. This washes away the concrete components and soils protecting the column base cap and foundation. For this reason, this bridge is likely to collapse in the near future. The exposed piles of the foundation have been clogged by debris carried by the flowing Ekulu river which obstructs the free flow of water. However, there are possibilities of the river carrying heavy wood logs and massive loose concrete components and colliding with the exposed pile base cap and piles of the foundation. This can lead to instability and loss of structural integrity of the bridge. From the cross-examination exercises carried out on this bridge, there is a serious distress call for maintenance and repairs on the bridge to evade imminent failure and collapse.
